## Research Article

# Cement Debonding: Is it a Problem with Antibiotic Cement Coated Nails?

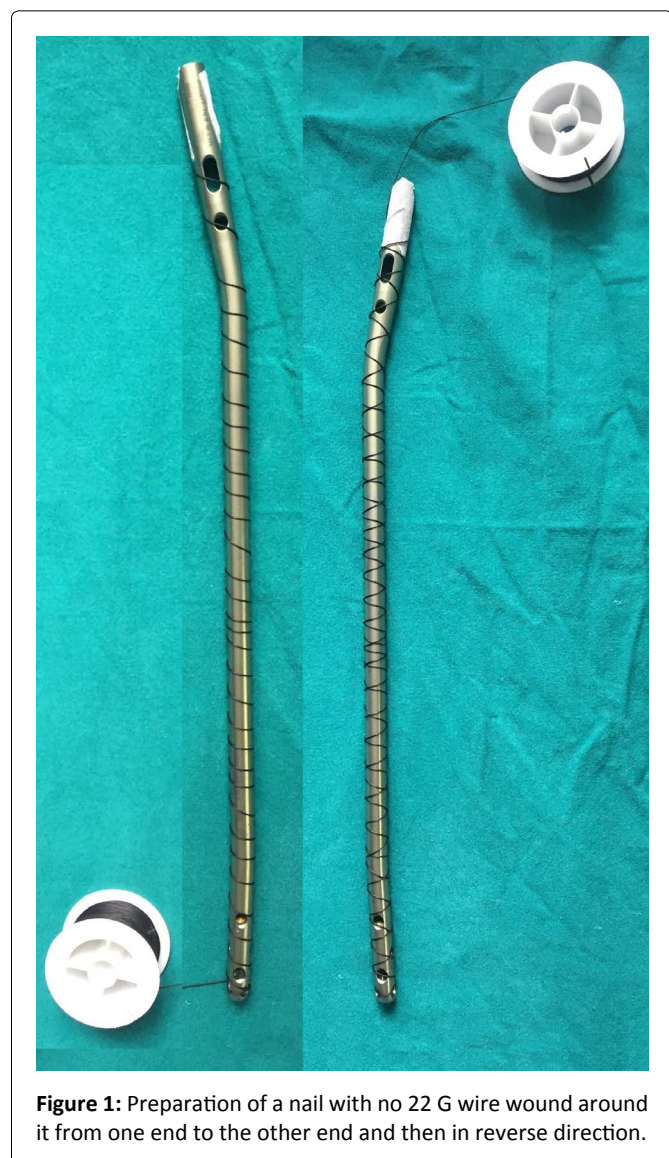
**Figure 1:** Preparation of a nail with no 22 G wire wound around it from one end to the other end and then in reverse direction.

G stainless steel cerclage wire is selected. Stabilize the tip of the cerclage wire at one end of the nail with a sterile adhesive tape and wind it around the nail till the other end of the nail. Once the cerclage wire reaches the distal end of the nail, then wind it back to the proximal end of the nail. Then cut the cerclage wire and twist the ends of the wire together after removing the adhesive tape (Figure 1). If the medullary canal is unusually narrow then a 6 mm Rush nail is selected and no. 22 G wire was used for winding. Cement was hand-rolled on the prepared nail/Ender's nail and it was passed through a preselected diameter hole of a metal gauze. The forward and backward movement through the corresponding diameter of the gauze was done several times while the cement is setting to prepare ACN of uniform diameter (Figure 2).

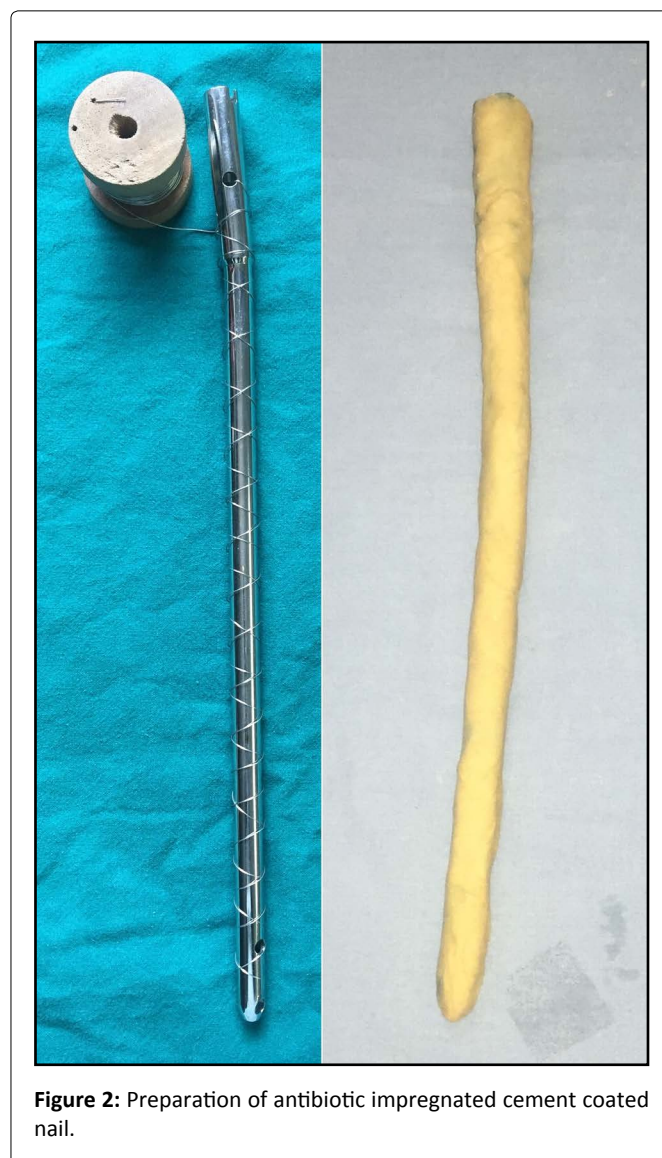
**Figure 2:** Preparation of antibiotic impregnated cement coated nail.

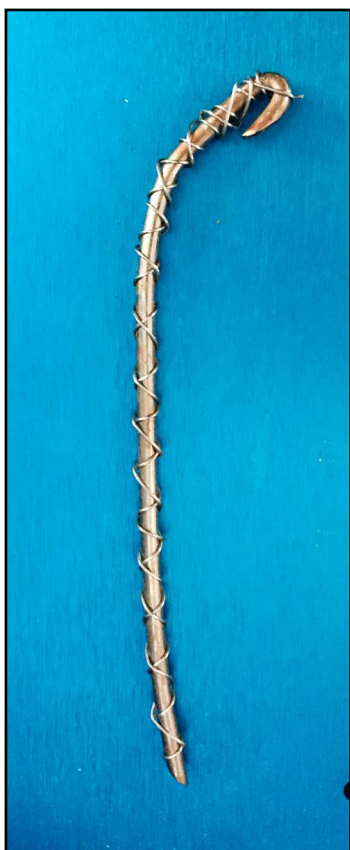
Figure 3: A bent Rush nail with No 18 G wire wound around it to prepare a hemiarthroplasty ACN.

For cases of infected hemi-arthroplasty or total hip joint replacement, a Rush nail is bent to about 120 degrees at neck-shaft angle and No. 18 or No. 20 G stainless steel wire was used to wind around it as described above (Figure 3). Then antibiotic mixed cement was applied on to the prepared nail. The shape and diameter of the medullary canal of the proximal femur and bone defects in trochanter are carefully assessed and the implant is prepared to occupy maximum space within the canal but nearly conical to be able to extract easily. Once or twice a trial insertion was done into the proximal femur while the cement is still soft to make sure it goes-in and come-out easily (Figure 4).

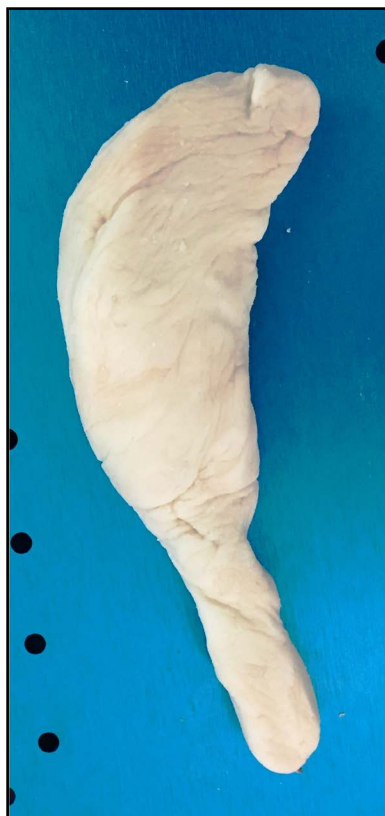
Figure 4: Antibiotic impregnated cement coated Rush nail for proximal femur implant.

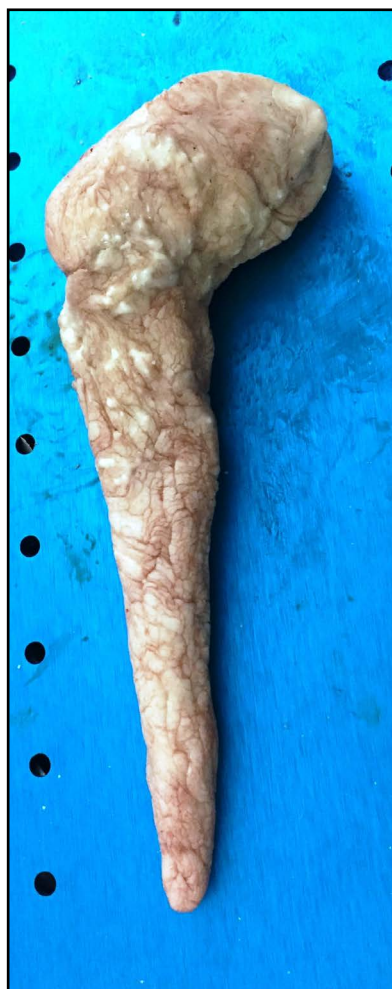
Figure 5: A non-articulating upper femur ACN prosthesis, explanted fully intact.

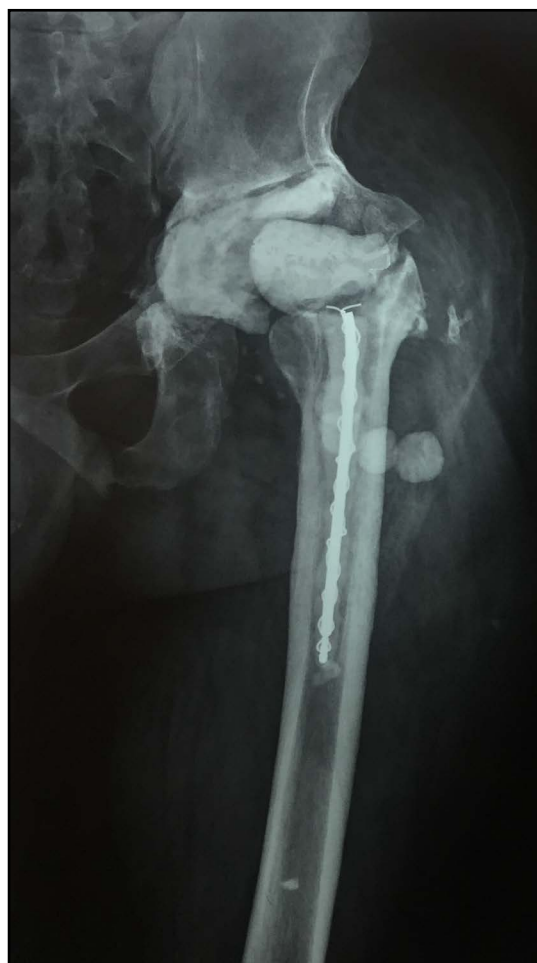
Figure 6: Radiograph of ACN in upper femur three years after insertion.

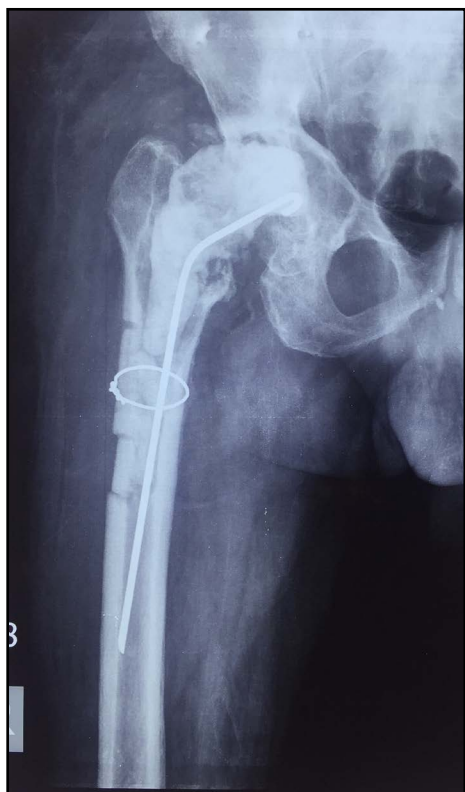
**Figure 7:** Cement de-bonding from a smooth Rush nail while inserting with almost no cement in the lower half of the nail (Courtesy Dr. Aachi).

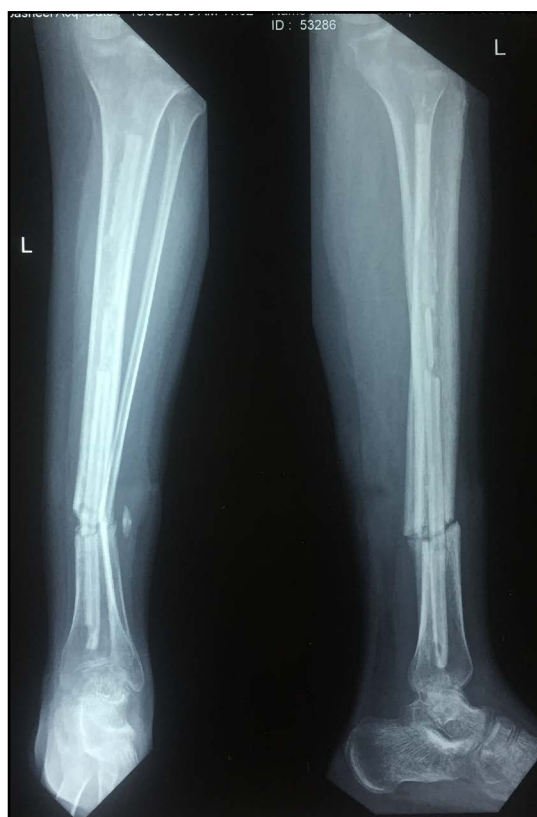
**Figure 8:** A tibial non-union with retained cement mantle through the entire medullary canal.

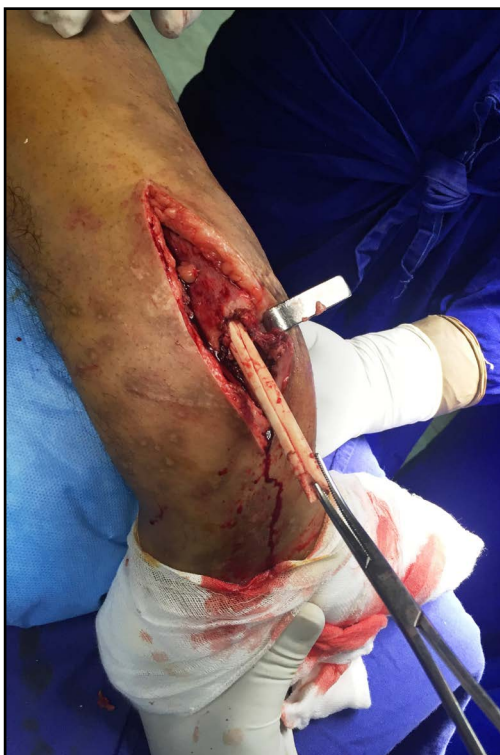
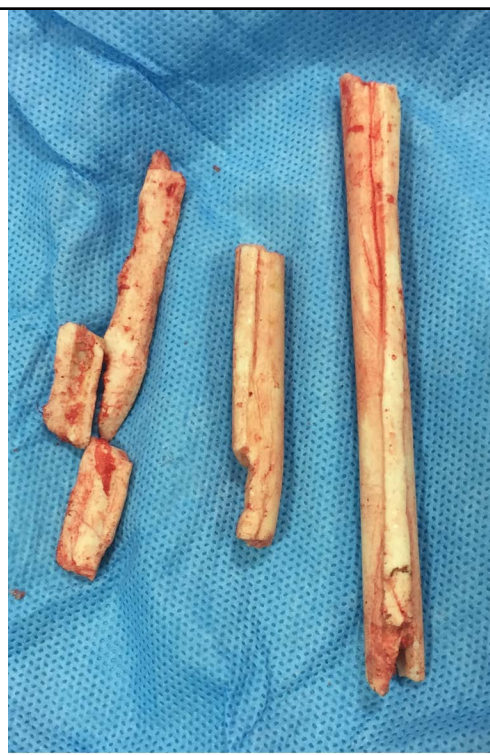
**Figure 9:** (a) Removal of the pieces of cement mantle after opening the fracture; (b) A picture of the removed cement mantle tubes.

ing is common with canulated non-slotted nails, though matt finished nails may offer some advantage [2]. Some authors recommended allowing time for the cement to set and bond well with the nail, adequate over reaming, to drive-in the nail with hand and not to hit with a hammer while inserting the nail to avoid cement debonding [4,5,9]. Once the infection is under control the cement coated implant needs to be removed and a definitive fixation is done. However, cement debonding occurs to varying degrees despite all the above precautions. There can be de-bonding of the cement from the metal implant while preparing, inserting-commonly in cases with segmental defects (Figure 7), Courtesy Dr. Aachi, or more commonly identified at the time of its removal [3]. Thonse, et al. reported debonding in 20% of cases with two cases of retained cement in the medullary canal [3]. Saravanan, et al. reported 2 cases of de-bonding out of 25 cases [9]. There are other studies reporting cement de-bonding in the literature, though details of numbers were not given. Hence they were not included in this article. Our hospital being a tertiary care centre sometimes we get cases with retained pieces of cement in the bones after their initial treatment with ACNs elsewhere. In one case the primary surgeons treated an open fracture of both bone of the leg with an ACN in the tibia. They successfully controlled the infection and got the soft tissue cover. At planned second stage surgery the smooth Ender's nail which was used for preparing the ACN slipped out of the tibia leaving the entire cement mantle inside the medullary canal (Figure 8). He was then referred to our centre. This poses a difficult problem which is under-reported in the literature. If the fracture has healed well and the infection is fully under control perhaps the remaining pieces of cement in the medullary canal will be of no significance. However, if the infection still lingered on, the procedure may need to be re-done with another ACN. For that, the medullary canal needs to be thoroughly cleared of any residual cement which in itself can be a source of infection. Many times the infection may have cleared but the fracture may still have not united and it may need definitive fixation. Unless the pieces of cement mantle left in the canal are not removed, no further definitive procedure can be done. Attempts to remove the bits of cement using revision arthroplasty cement removal instruments may be successful in some cases. In cases where the fracture has not united, exposing the fracture site may serve a dual purpose of open removal of the intramedullary cement and for freshening and bone grafting of the fracture site (Figure 9a and Figure 9b) along with definitive fixation of the fracture, which we did for the above case.
