Research Article

Review on Baste Soil Improving Approaches for Water Logging and Soil Salinization Problems in Agricultural Land of Ethiopia

Kasye Shitu^{1*}

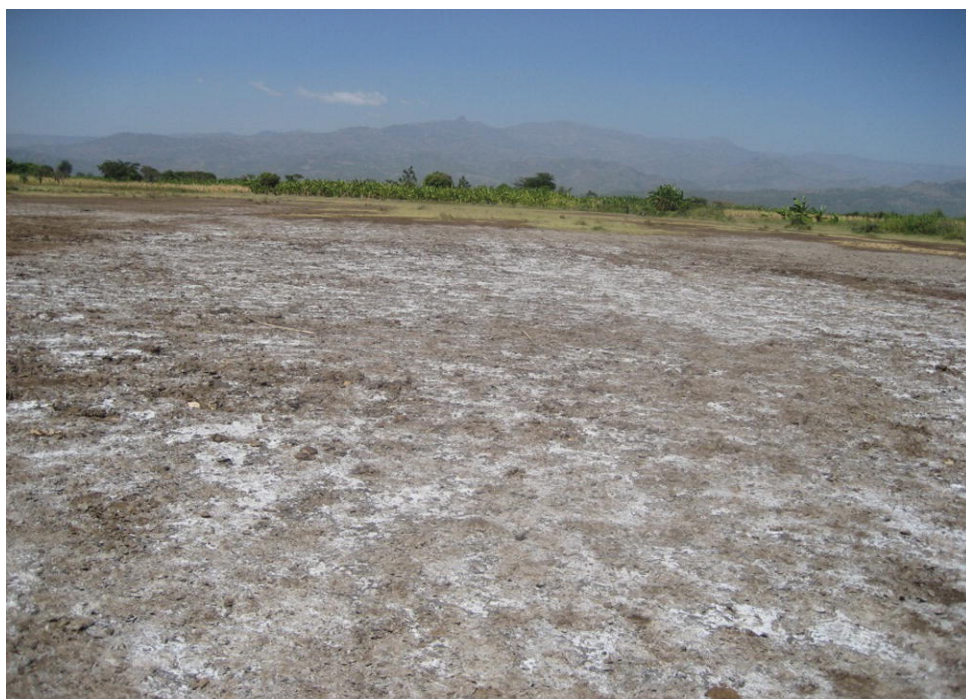
Figure 2: Surface salt crystals spread in the central part of the Sege Irrigation Farm, South Ethiopia.

Poor irrigation and drainage management problems are perceived as the main causes for salinity development in Ethiopia [21]. As cited by Adhanom [12], Gebremeskel, et al. [23] indicates that the soil salinity problems in Ethiopia stem from use of poor-quality water coupled with the intensive use of soils for irrigation, poor on-farm water management practices and lack of adequate drainage facilities. Qureshi, et al. [9], also indicates water shortage for irrigation and declining irrigation water quality as major factors for causing salinity development in Ethiopia. As an indicator, Zewdu, et al. [8], clearly states that, surface salt crystals spread in the central part of the Sege Irrigation Farm, South Ethiopia

is crucial problem for the productivity of the area due to combined effect of poor-quality irrigation water, intensive use of soils for irrigation and lack of adequate drainage facilities (Figure 2).

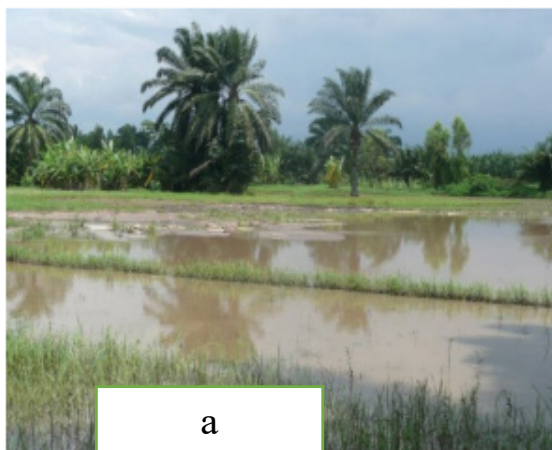
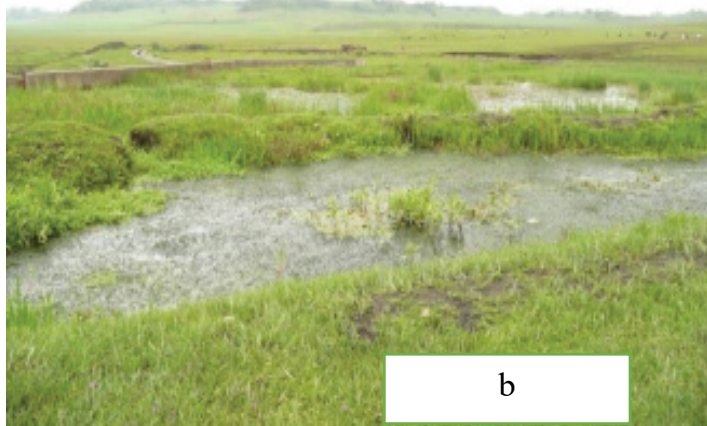
Figure 3: Temporary waterlogging after a heavy rainstorm (a) and permanent waterlogging resulting from ground water contribution (b).

According to Mati [24] waterlogging is a condition of land in which the soil profile is saturated with water either temporarily or permanently (Figure 3). Waterlogging, caused by flooding, excessive rains and poor drainage is a serious abiotic stress determining crop productivity worldwide [25]. In waterlogged lands, the water table rises to an extent that the soil pores in the crop root zone are saturated resulting in restriction of the normal circulation of air. This causes a decline in the level of oxygen and increase in the level of carbon dioxide. These affects plant growth by reducing soil aeration around the root zone [3] and remains a significant constraint to cereal production across the globe in areas with high rainfall and/or poor drainage [26].

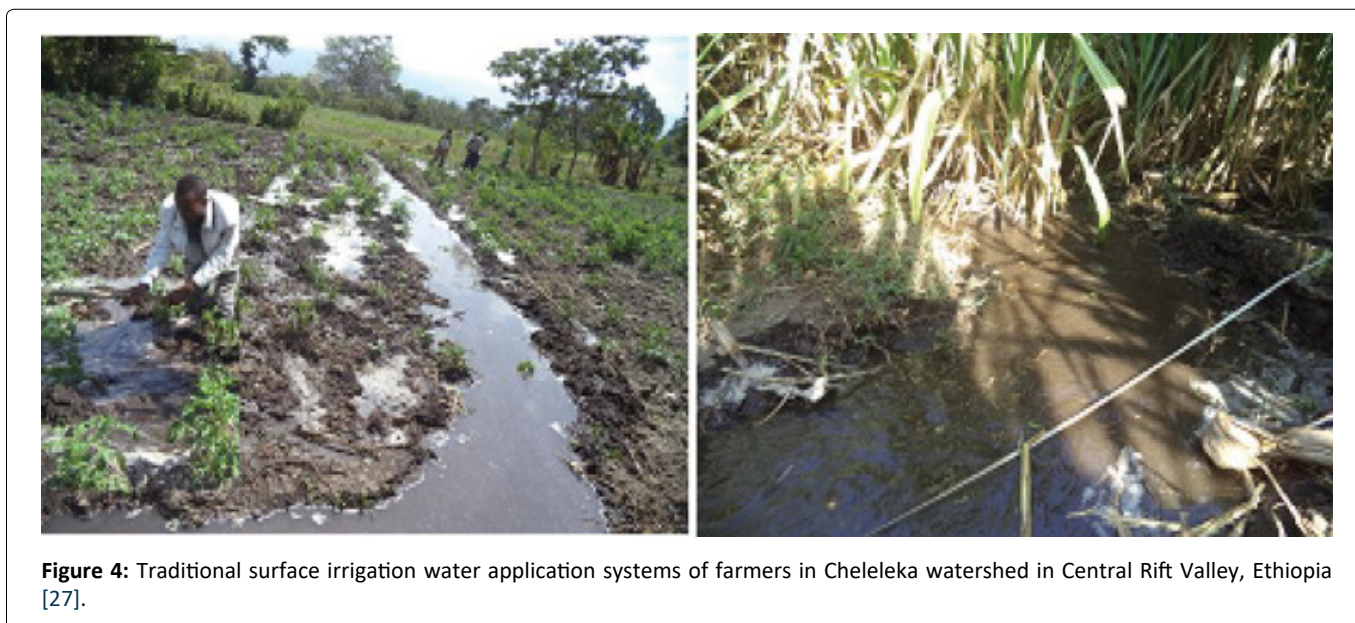
Figure 4: Traditional surface irrigation water application systems of farmers in Cheleleka watershed in Central Rift Valley, Ethiopia [27].

The lack of functional drainage system and poor water management practices especially in developing country like that of Ethiopia have significantly contributed to the frequent occurrence of waterlogging and salt build-up in irrigation fields [4,6]. In Ethiopia Waterlogging is the main drainage problem in the small-scale irrigation schemes in the Vertisols dominated highland areas [4]. In most agricultural land of Ethiopia drainage systems is either non-existing or malfunctioning [21]. In line with this Gebrehiwot [4], reported that lack of functional drainage system and poor water management practices have significantly contributed to the frequent occurrence of waterlogging in Ethiopia. Teshome, et al. [27] also, reported that mismanagement of irrigation water influences agricultural productivity and efficiency of water uses and maybe come cause of water logging in the area (Figure 4).
