## Case Report

# A Failure Case of Double Button Plate Fixation for Treatment of Nonunion of Patella Fracture

Tianjin First Center Hospital, Fukang Road No. 24, Nankai District, China

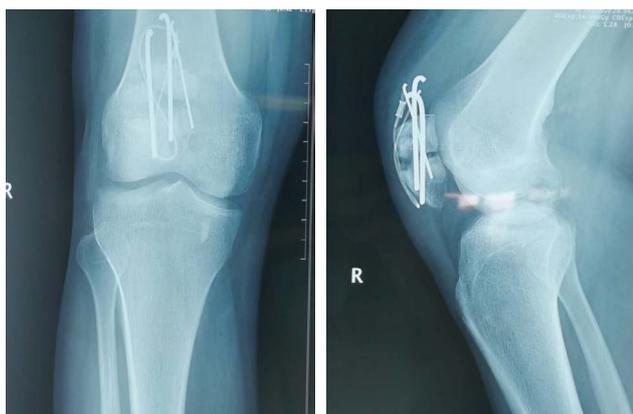
Figure 1: Preoperative radiograph of nonunion of patella fracture.

We identified one case of patella fractures operated on at local department in September 2019. But the fracture was still not healing in March 2020 (Figure 1). The male with an age of 50 years. The patient received fixation by means

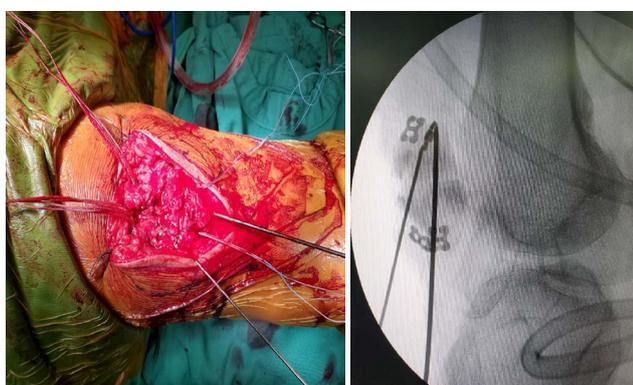
Figure 2a: Intraoperative radiograph of double button plate fixation.

fracture, and the position of titanium plate was acceptable. Limb was fixed with plaster at 0 degree of extension.

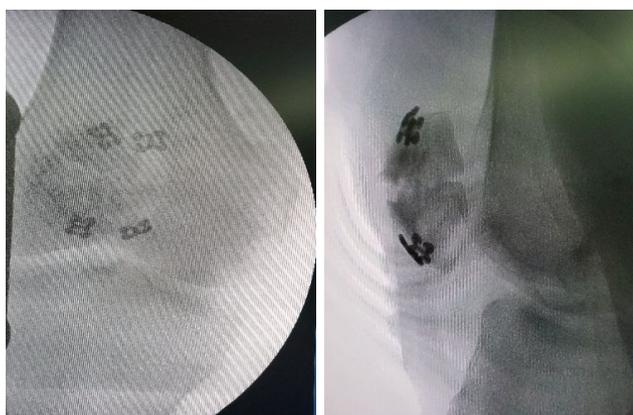
Figure 2b: Intraoperative radiograph of double button plate fixation.

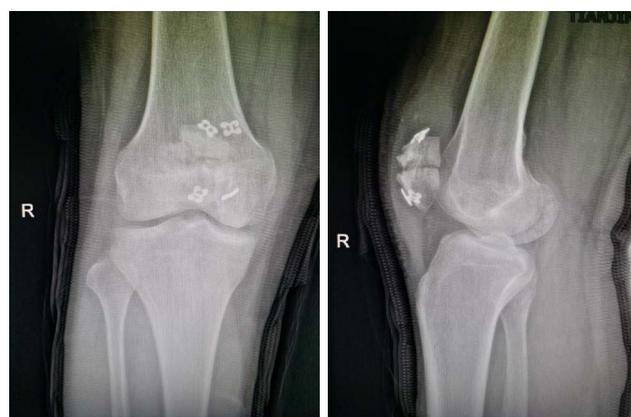
Figure 3: Postoperative radiograph of double button plate fixation (2 days).

Postoperative radiographs were taken the day after surgery. Patient was given a plaster as protection postoperatively. In general, 0 to 90 degrees of flexion in-brace was allowed for first 4 weeks postoperatively. Patients were given their first follow-up appointment at 2 weeks postoperatively for wound inspection, then they were followed up every 2-4 weeks to monitor for functional return and clinical/radiological fracture union (Figure 3, Figure 4, Figure 5, Figure 6 and Figure 7).

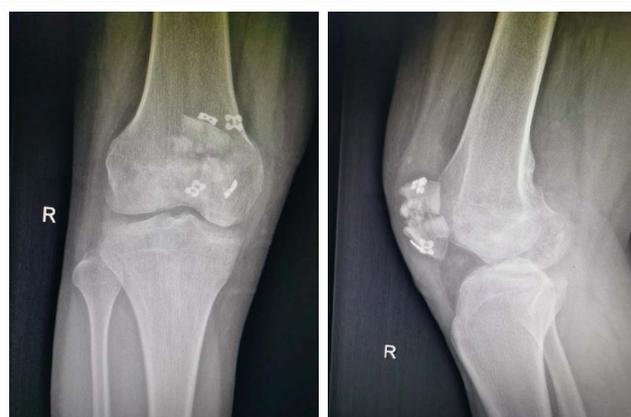
Figure 4: Postoperative radiograph of double button plate fixation (7 weeks).

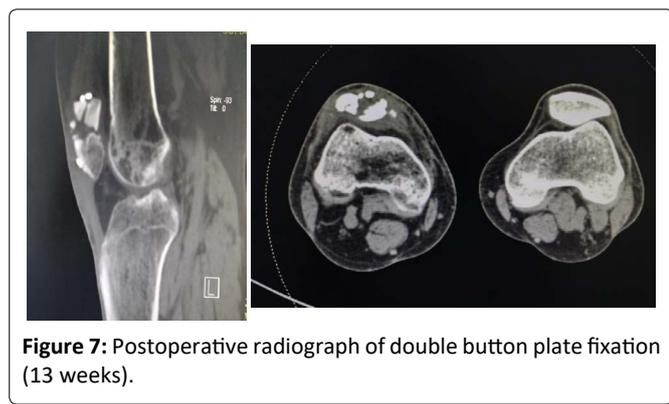
The case was loss of fracture fixation and delayed postoperative period again. Although the patient can kneel in the follow-up 6 weeks, no implant breakage, infection among, and was not noted to have double button plate dislodgement upon follow-up X-rays, the fracture was still unhealing and after 21 weeks operation, and demonstrated fracture displacement (Figure 8).
